Post Insulator Blade Adaptor

After a damaged insulator arm dropped a transmission line, Sunflower Electric in Great Bend, KS needed to avoid the huge cost of future drops. They turned to Pelco Products, Inc. for a solution. Our engineering team designed and built the all new Post Insulator Blade Adaptor.

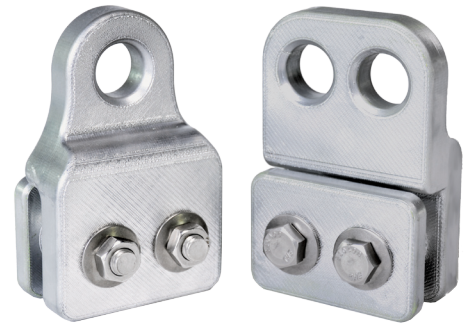
Available in single mount (SP-6201) or double mount (SP-6202) models.

#SP-6201 Single Mount
#SP-6202 Double Mount
(Patent Pending)

Instead of the costly, labor-intensive process of replacing the entire post insulator, simply clamp the stainless steel adaptor over the damaged aluminum blade. The threaded body (with anti-seize lubricant) is secured by two 2-3/4" long stainless steel bolts, utilizing Belleville washers for a solid mounting system. The entire process takes less than five minutes, and can be done by one person. The Post Insulator Blade Adaptor is durable, easy to install and saves thousands of dollars.

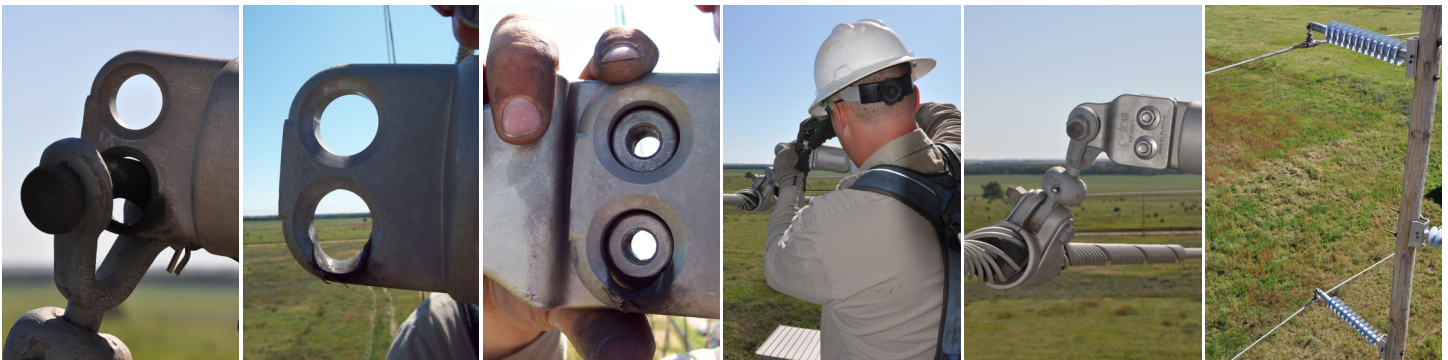
Visual evidence of steel-against- aluminum damage

Remove the yoke and see the extent of the wear

Place the new Post Insulator Adaptor over the damaged blade

Easy, one man installation with standard tools

Reattach the line in less than 5 minutes
